**NL INDUSTRIES/TARACORP SUPERFUND SITE GROUP**  
**Leed Environmental, Inc.**  
**Van Reed Office Plaza**  
**2209 Quarry Drive, Suite C-35**  
**Reading, PA 19609**  
**Telephone: (610) 670-7310**  
**Facsimile: (610) 670-7311**

**Re: NL Industries/Taracorp Superfund Site; Granite City, Illinois**  
**First 2017 Semi-Annual Operation and Maintenance Inspection (May 2017)**

**NL Industries/Taracorp Superfund Site  
Inspection Log - Operation and Maintenance**

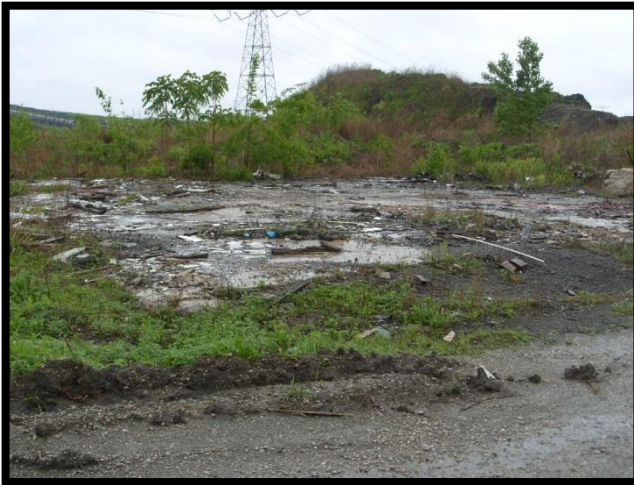
Photograph 7: Slough Road, concrete debris, foundation of former Robin's Nest Lounge.

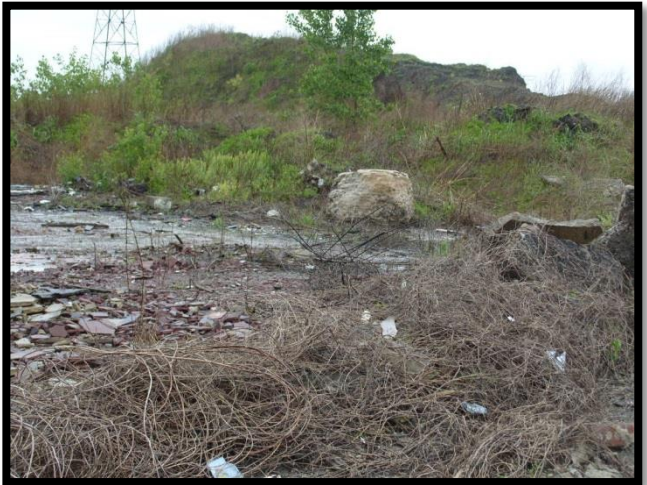
Photograph 8: Slough Road, concrete debris, foundation of former Robin's Nest Lounge.

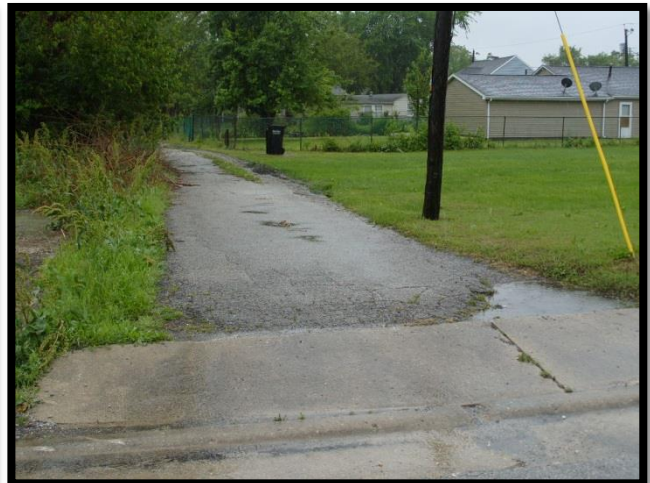
Photograph 17: Alley between Calhoun Street and Douglas Street (view west from Line Alley); several holes have been filled with asphalt since June 2012 inspection.

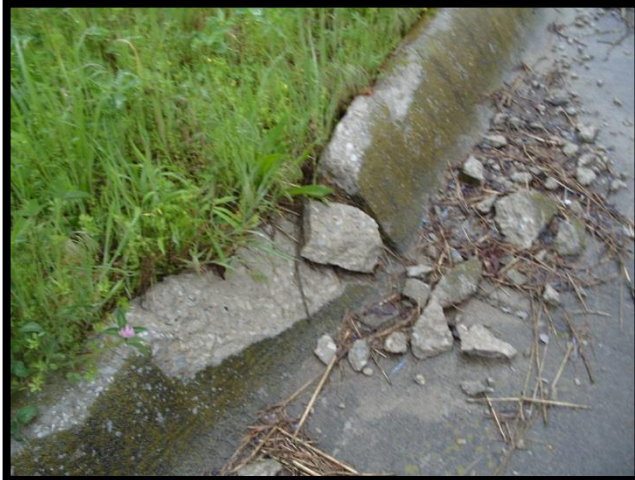
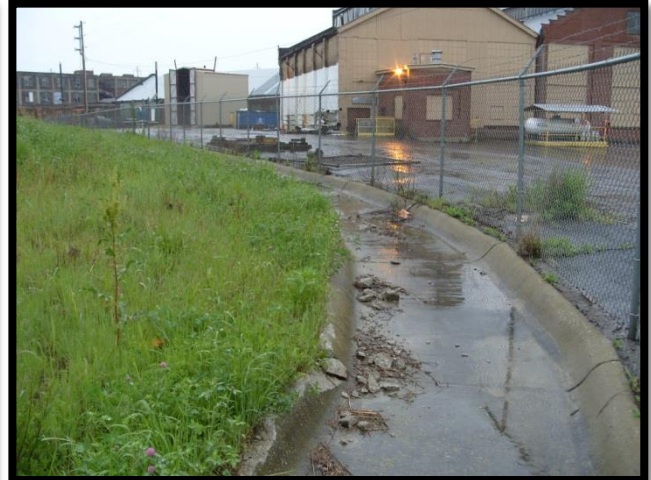
Photographs 15 and 16: Concrete drainage swale, crack in concrete along northwestern side of Taracorp pile.

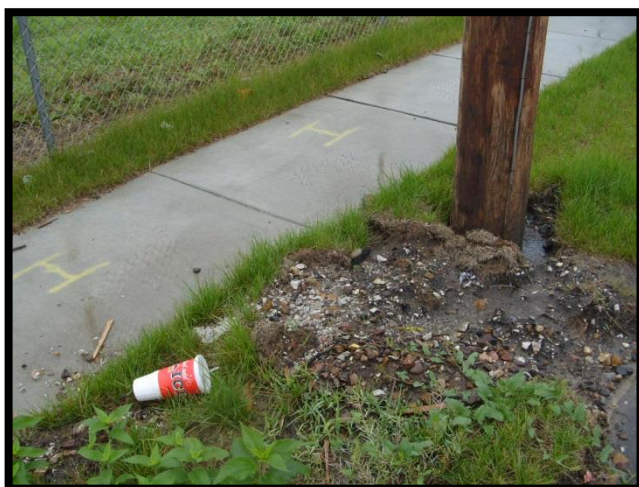
Photograph 69: Disturbed soil at base of utility pole along State Street.

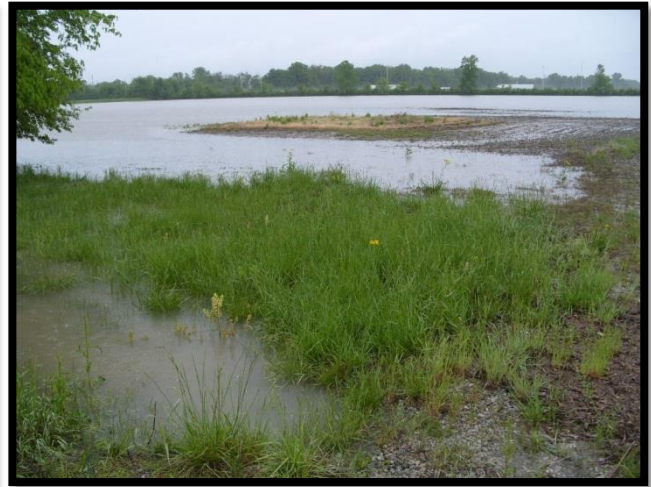
- At Sand Road (a remote fill property remediated by EPA where lead-impacted soil and/or battery case chips may remain in place at a depth below three feet), most of the property was submerged under water (Attachment 7, photographs 1-4) due to recent rainfall, except the foundation area of the former building where scattered battery case chips are visible on the ground surface. No evidence of disturbance of the soil cover was observed.

Photograph 2: Sand Road property.

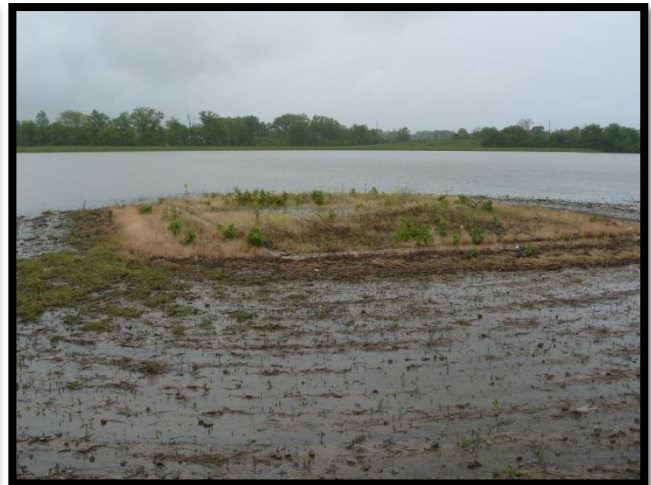
Photograph 4: Sand Road property.
